## **Stage 1 Road Safety Audit**

**Residential Development, Cairns Road, Sligo**

On behalf of Novot Holdings Ltd

**March 2022**

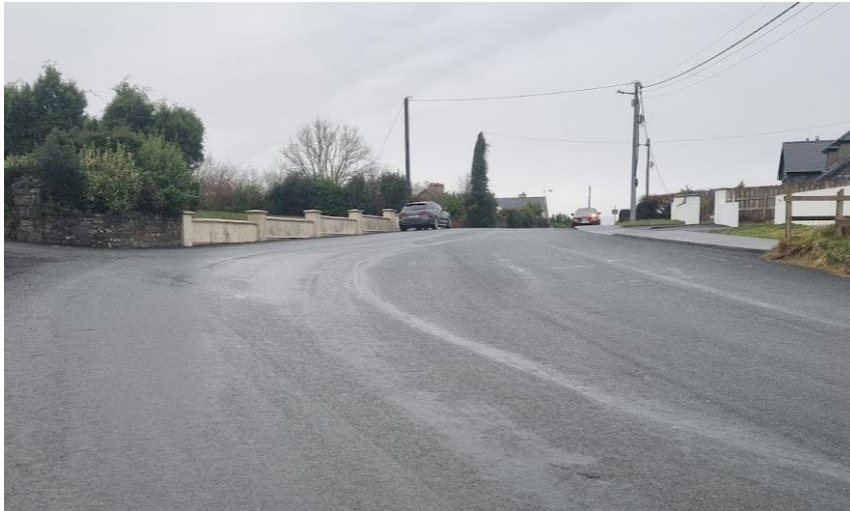
#### 3.3.2 Approach to development entrance from the south

**Problem:** Cairns Road to the south of the development is very wide and undefined. The proposed development footpath projects further forward than the adjacent house front wall.

**Hazard:** Northbound Cairns Road drivers may follow the line of the boundary wall and impact with the new footpath.

**Recommendation:** Ensure the protruding footpath is conspicuous to approaching drivers.

3.3.2	Yes	Yes	We have amended the kerb line to the South side of the proposed entrance, it now closely ties into the boundary wall to the south and will ensure that the footpath kerb line is conspicuous to approaching drivers.

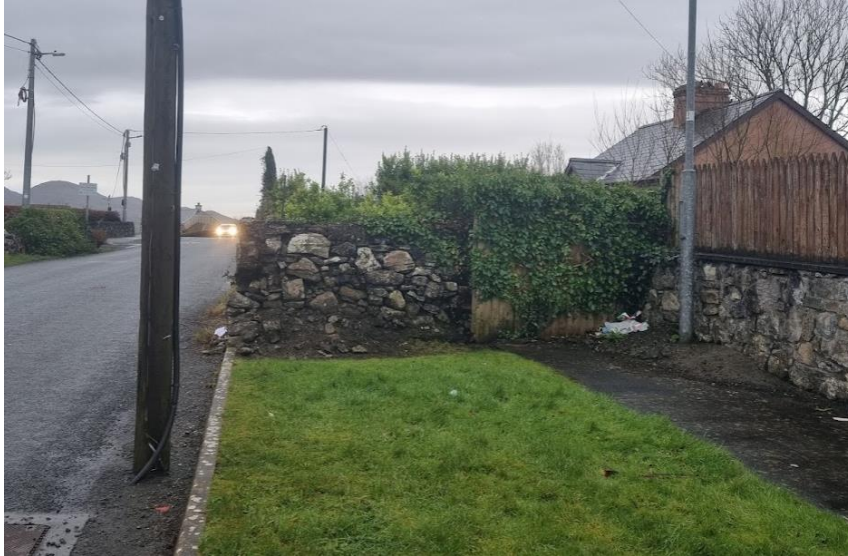
### 3.3.3 Cairns Road – Footpath Linkage

**Problem:** The proposed footpath on Cairns Road to the north of the development does not abut the existing footpath network.

**Hazard:** Pedestrians may decide to step into the carriageway, rather than attempt to cross the grassed (possibly muddy) verge. Impact from motorised traffic may result.

**Recommendation:** Ensure a suitable width footpath linkage is provided.

3.3.3	Yes	Yes	The proposed footpath now ties into the existing footpath as shown on the updated roads drawing.	
3.3.4	Yes	Yes	The Utility pole will be removed and services undergrounded along the proposed entrance as part of the works.

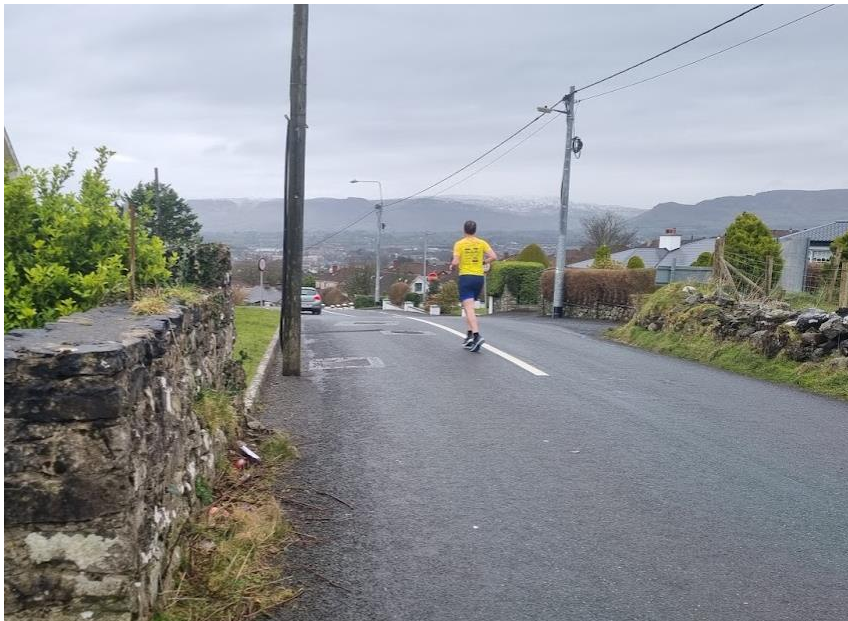
### 3.3.4 Cairns Road – Utility Pole

**Problem:** There is a utility pole within the carriageway adjoined to the development site. The existing stone wall to the south of the pole will be removed by the development.

**Hazard:** The existing wall may offer protection to the pole from northbound traffic. Removal of the wall may increase the risk of vehicle strikes of the pole.

**Recommendation:** Relocate the pole outside of the carriageway.

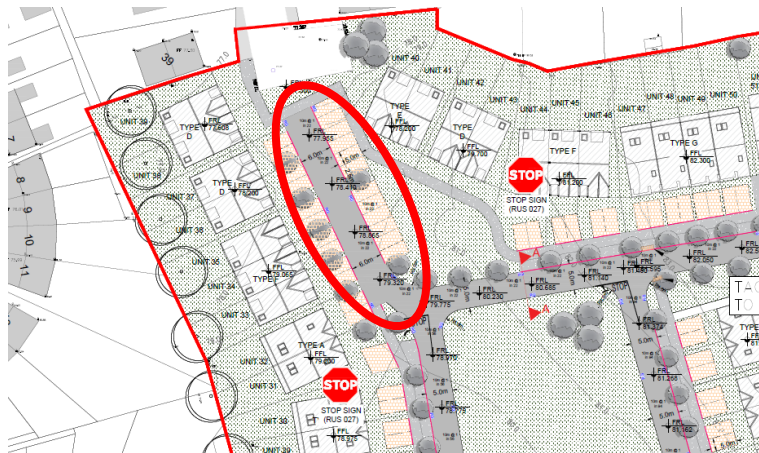
### 3.3.5 Access Road for Units 33-43

**Problem:** There is no footpath adjacent to the carriageway in this area. It is therefore assumed this carriageway is intended to be a shared use surface. There is no obvious change in the character, level or surface finish to this area.

**Hazard:** The motorist is likely to drive in this area as if they were on a standard carriageway, without due care for NMU traffic. Impacts may result.

**Recommendation:** Redesign this area such that the motorists will easily understand they are within a shared use area.

3.3.5	Yes	Yes	The proposed shared use area will consist of a raised table with flush kerbs and with a coloured surface course.	
3.3.6	Yes	Yes	The junction priority has been amended as per recommendations.

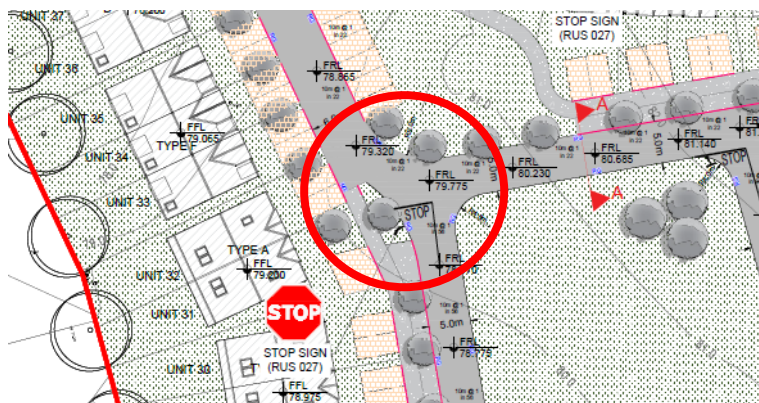
### 3.3.6 Junction control in front of Units 31/32

**Problem:** Further to Problem 3.3.4 above, users exiting a shared-use zone are likely to yield to all other users in the area, however motorists traveling north passing units 29-31 are instructed to stop at the junction.

**Hazard:** Users from both roads may initially stop waiting for the other to move, and then both may proceed at the same moment. Impact may result.

**Recommendation:** Amend the junction priority to show the stop sign / line on the shared-use area.

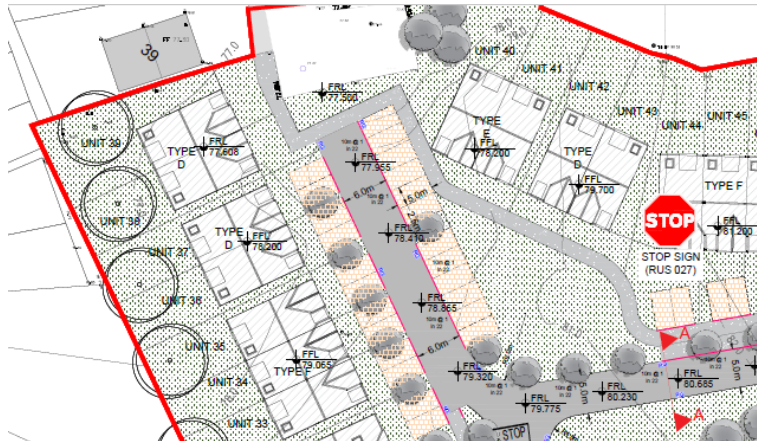
### 3.3.7 Shared Use Area – Turning

**Problem:** There is no turning room for the bin wagon within the shared-use area. Furthermore, if car drivers find there is no vacant parking spaces they may be required to reverse over long distances.

**Hazard:** The reversing vehicle may impact with pedestrians / cyclists in the area.

**Recommendation:** Provide a turning head or link the carriageway through to the Ard Cairn estate.

3.3.7	Yes	Yes	Autotrack Analysis has been undertaken on a refuse and fire truck reversing back into the shared area. The above noted change in priority of the junction will help
