## **Stage 1 Road Safety Audit**

**Residential Development, Cairns Road, Sligo**

On behalf of Novot Holdings Ltd

**March 2022**

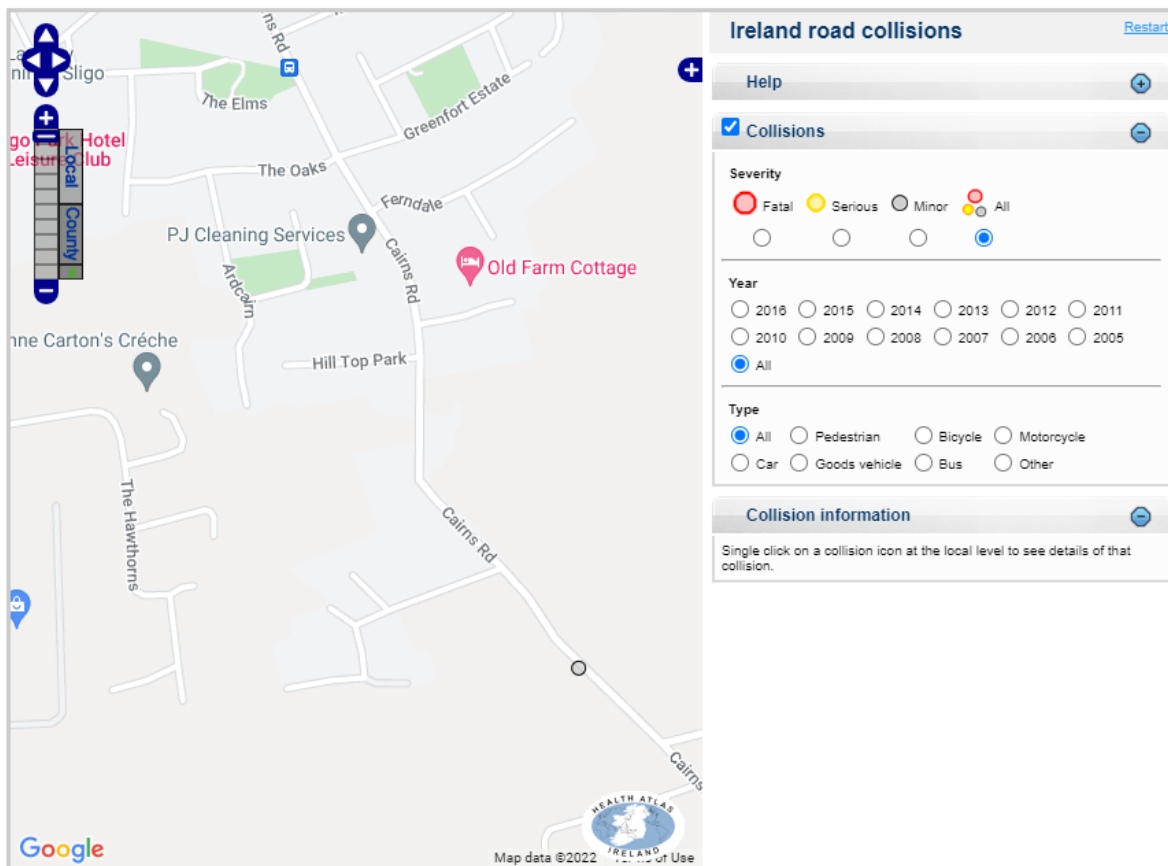
**Hazard:** Ponding and possible freezing of surface water may result in skid collisions.

**Recommendation:** Provide positive drainage on Cairns Road for the full extent of the proposed footpath.
